EP-011

악간 고정용 나사와 거닝 스플린트를
병용한 무치악 노인 환자의 하악 과두
골절 치료: 증례 보고

Management of Mandibular Condyle
Fracture in an Edentulous Geriatric Patient
Using IMF Screws and a Gunning Splint: A
Case Report

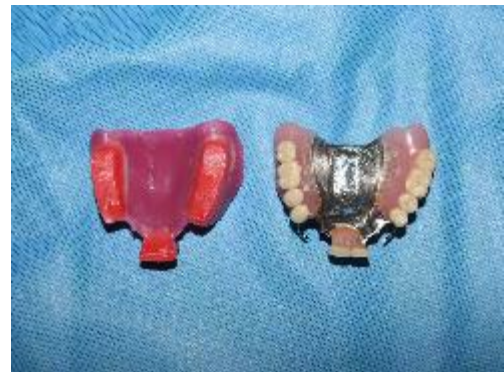
Fig. 2. (Left) Newly fabricated maxillary Gunning splint design to expose IMF screw heads for rubber band application. (Right) The patient's original mandibular removable partial denture (RPD) with metal framework, which was found damaged at presentation and could not be utilized for intermaxillary fixation.

Methods: A 74-year-old edentulous female patient presented with a right mandibular condyle fracture and a 2-cm chin laceration following a slip down. Examination revealed malocclusion and trismus (2-finger width). Her maxillary denture was deformed at presentation, precluding use of the existing denture. Under local anesthesia, four 8-mm IMF screws were placed at the upper and lower gingivomucosal junctions between the canines and first premolars. In collaboration with the dental department, a new Gunning splint was modified to expose screw heads for rubber band application.

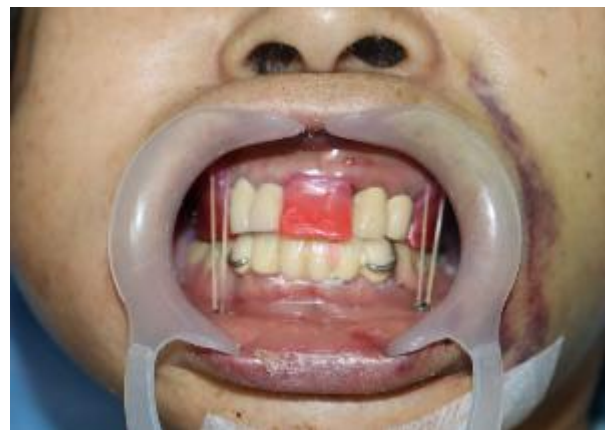
Fig. 3. Clinical photograph demonstrating intermaxillary fixation with rubber bands applied between the IMF screws and the Gunning splint.

Results: IMF was successfully established without general anesthesia or open dissection. The new Gunning splint restored stable occlusion lost due to fracture. The chin laceration has healed by primary intention, and the sutures were removed on postoperative day 5. IMF was maintained for 15 days. After rubber bands removal, the patient demonstrated stable occlusion and improved mouth opening without complications. Notably, the splint was fabricated without a conventional anterior feeding opening; nutrition was maintained on a liquid diet throughout fixation.
