EP-210

**경피적 혈관 성형술 이후
천층회선장골동맥 천공지 유리피판
(SCIP)의 혈관경 손상에 대한 사례군 연구**
(Vascular Pedicle Injury of the Superficial Circumflex Iliac Artery Perforator (SCIP) Free Flap Following Percutaneous Transluminal Angioplasty: A Case Series)

순천향대학교

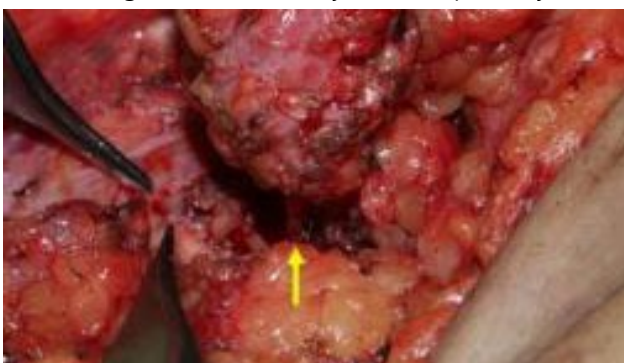
Fig. 1 Intraoperative view of SCIP flap elevation. The perforator (yellow arrow) was identified during dissection.

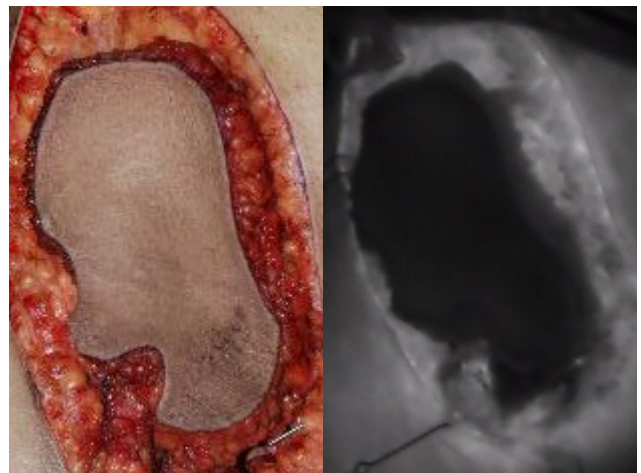
Results: Although preoperative ultrasonography suggested that the superficial branch of the SCIA was preserved, severe fibrosis and adhesions were observed around the origin of the vascular pedicle during flap dissection in all four cases. The main branch of the superficial SCIA was occluded, and distal perfusion was maintained through collateral flow from adjacent branches or the deep branch of the SCIA. These findings led to vascular pedicle compromise and flap failure.

Fig. 2 Intraoperative gross view of the elevated SCIP flap before pedicle division (left) and indocyanine green angiography demonstrating absent perfusion to the flap (right).

Conclusion: Prior percutaneous transluminal angioplasty may reduce donor vessel stability due to perivascular injury and fibrosis. Even with preoperative ultrasonography, false-positive assessments of vessel patency may occur. Therefore, meticulous preoperative evaluation with ultrasonography and/or CT angiography is essential in patients with a history of endovascular intervention, and alternative donor site selection or modification of surgical strategy should be considered. These findings underscore the importance of careful risk stratification in microsurgical planning.
